**FINAL REPORT
ROUND 10 DAM ASSESSMENT
WISCONSIN POWER AND LIGHT COMPANY – NELSON DEWEY
GENERATING STATION
SLAG POND, WPDES POND
CASSVILLE, WISCONSIN**

RE: FINAL Assessment of Dam Safety of Coal Combustion Surface Impoundments at the Nelson
Dewey Generating Station

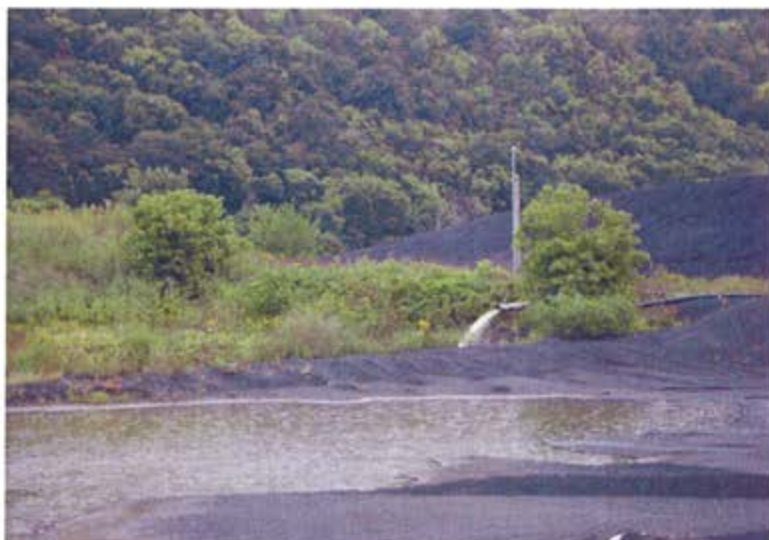
Figure 1 Trees needed to be removed on slag pond.

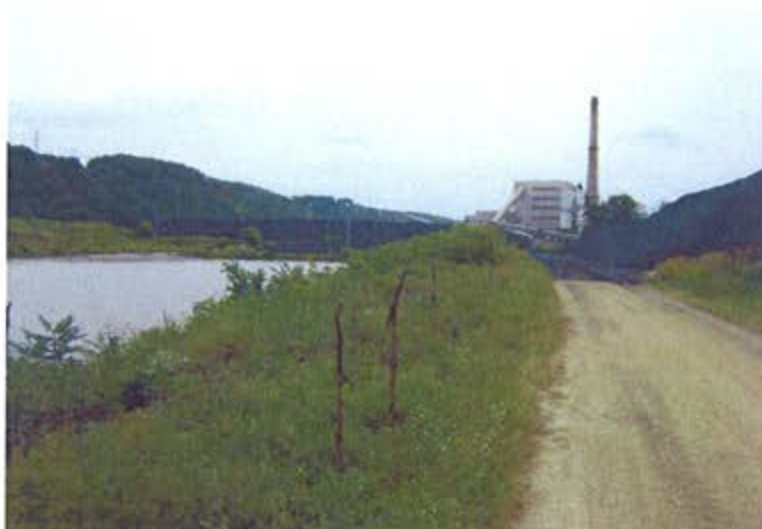
Figure 2 Need to finish cutting sumac.

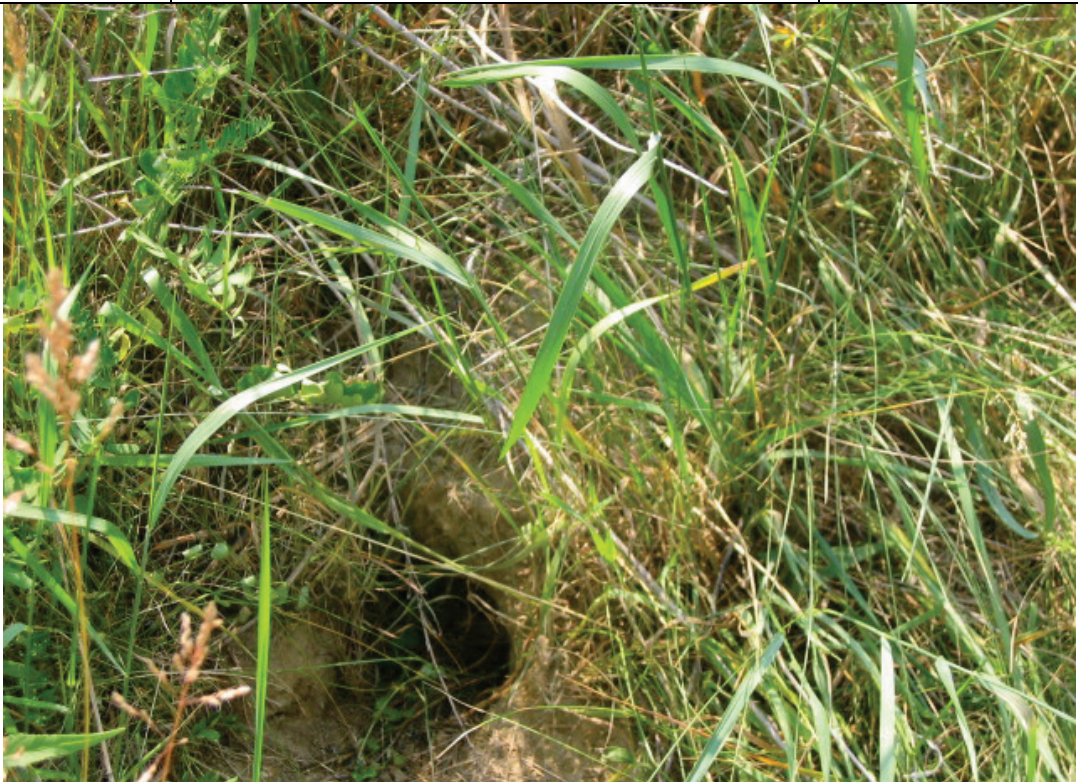
| Photo No. 11 | Date: 6/7/11 | | |

The crest of the Slag Pond had a gravel access road along the western, southern, and eastern embankments and was seeded along the remaining portions. The crest of the impoundment had occasional animal burrows present at the time of our assessment. The alignment of the crest of the impoundment appeared generally level with no large depressions or irregularities observed. Based on information provided by WP&L, the crest of the impoundment is at approximately elevation 625.0 feet MSL. No settlement was observed at the time of our assessment. There was approximately 8 feet of free board at the time of our assessment.

| Description: Animal burrow on the crest of the Slag Pond. | | | |

1. Repair sloughing on the downstream slope of the Slag Pond;
2. Protect the northwestern embankment of the Slag Pond from wave action erosion;
3. Control burrowing animals on and near embankment; and,
4. Fill animal burrows.

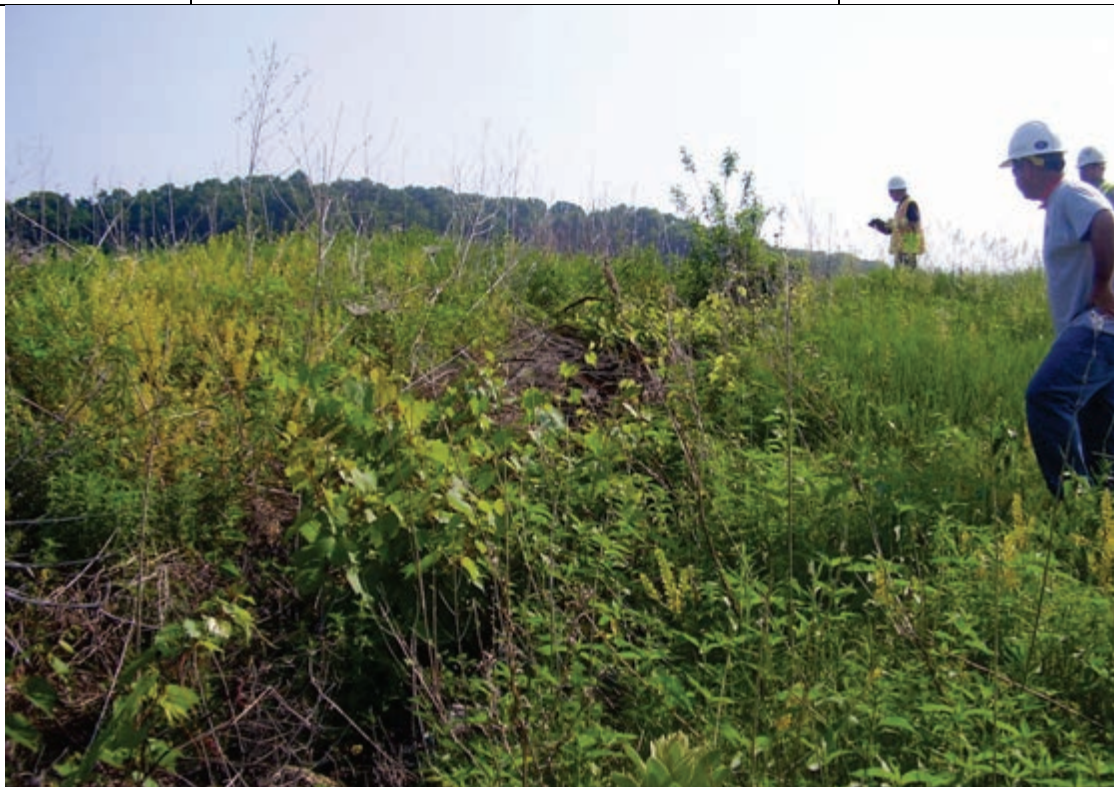
Armored portion of the northern embankment of the Slag Pond. Armoring present to protect against erosion from storm water runoff.

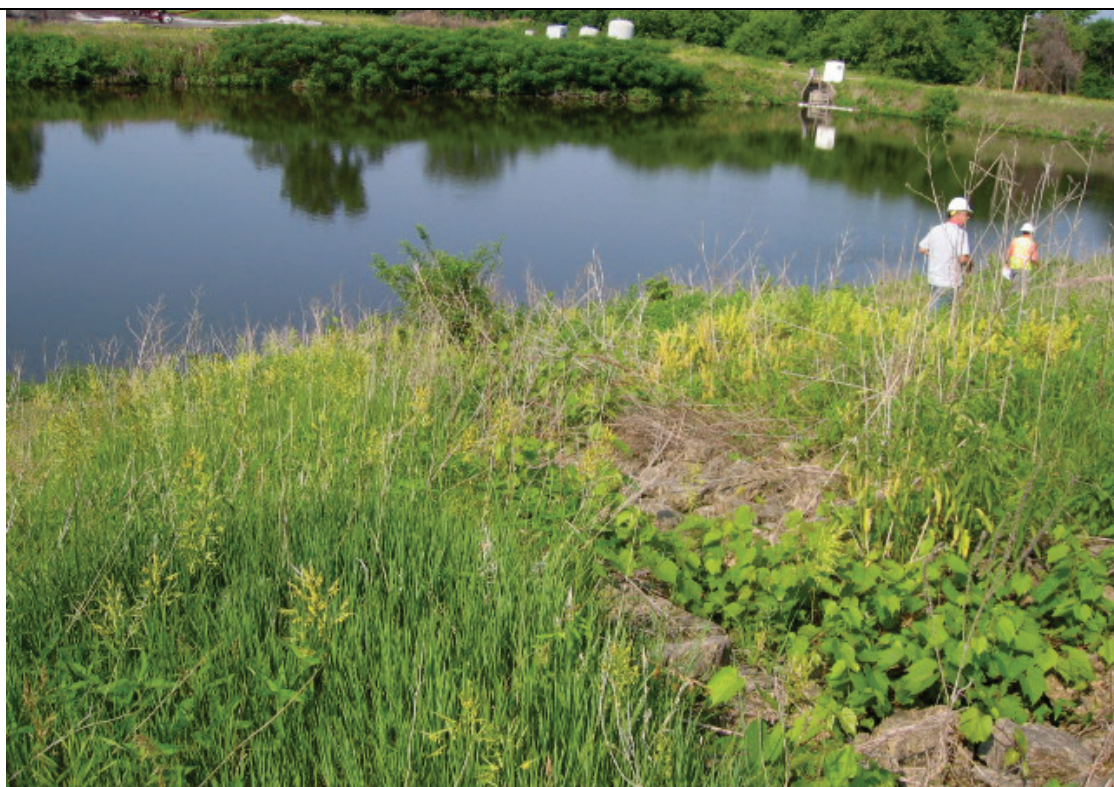
Photo No.
18

Armored portion of the northern embankment of the Slag Pond. Armoring present to protect against erosion from storm water runoff.

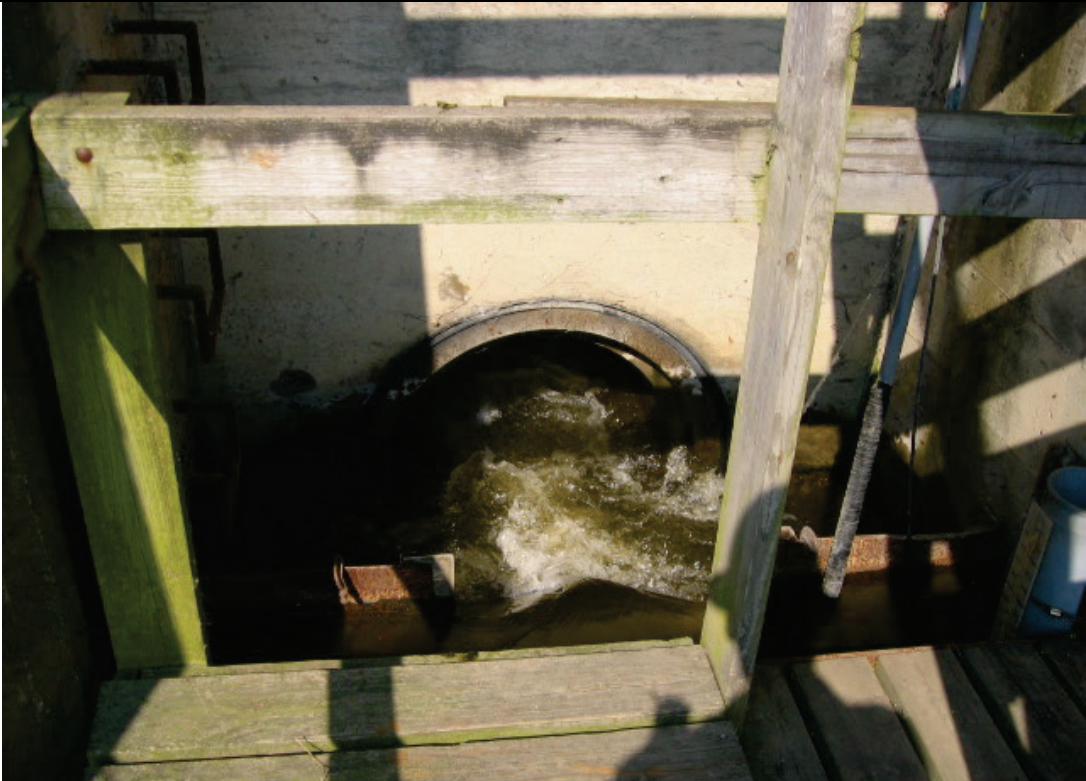
| Photo No. 19 | Date: 6/7/11 | | |

Water and CCW from the plant are discharged into the Slag Pond through a series of 12-inch diameter steel pipes which are located along the southern and eastern embankments of the impoundment. Water is discharged into the Slag Pond from the WPDES Pond through an 8-inch diameter HDPE pipe which is located near the northeast corner of the impoundment. The discharge pipes appeared to be in good condition. GZA observed the condition of the decant structure that transmits water from the Slag Pond to the Mississippi River. The decant structure appeared to be in good condition.

| Description: Decant structure and weir in the Slag Pond. | | | |

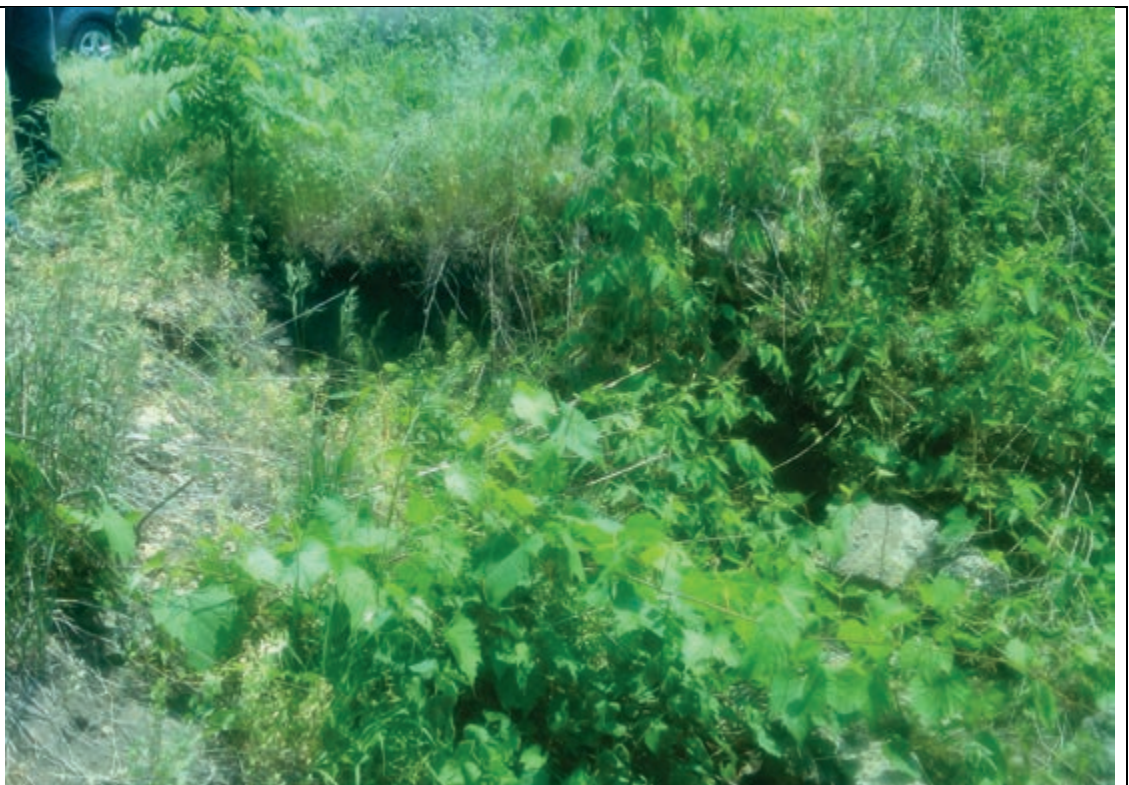
Photo No.
22

Description:
Erosional feature near the
crest of the Slag Pond.

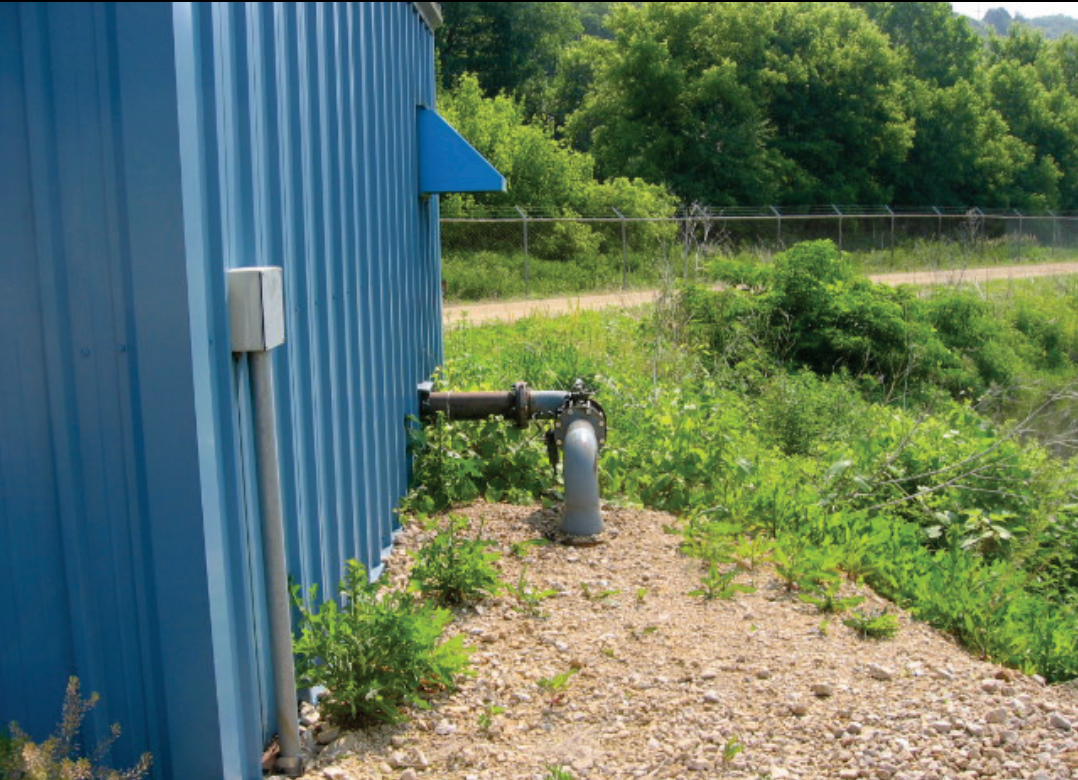
| Photo No. 41 | Date: 6/7/11 | | |

Water in the WPDES Pond is generally allowed to infiltrate or evaporate. In addition, water from the WPDES Pond is used for dust control. When necessary, water is pumped from the WPDES Pond to the Slag Pond via the pump house near the northern corner of the impoundment. The visible portions of the pump house appeared to be in good condition.

| Description: Pump house at the WPDES Pond. | | | |
